# NEW REQUIREMENTS TO THE EMERGENCY EXITS OF BUSES

**Dr. MATOLCSY, Mátyás**

Paper Number: 09-0181

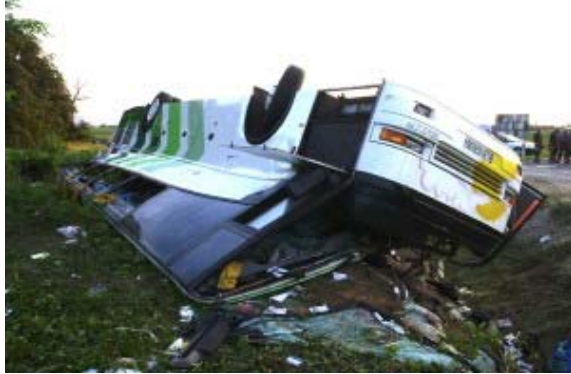
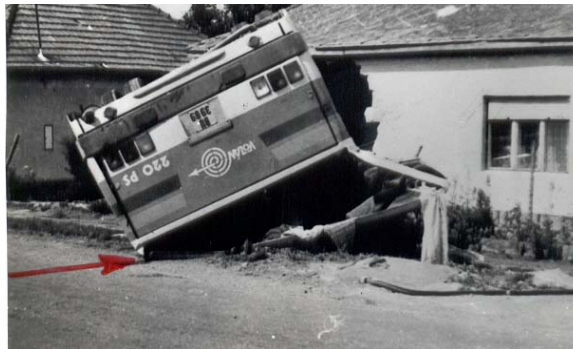
**Figure 1. General collapse of the superstructure in rollover**

- Certain, but not well defined positive co-operation is presumed among the passengers when evacuating the bus.
- Certain, but not well defined outside help is presumed (but not organized, well trained help) e.g. given by the driver, or by one or two younger, stronger male passengers using first the EE, or by outside people being close to the accident.
- The assigned side-wall emergency windows may be used without the very negative effect of the sharp, pointed remaining parts of the broken window. This negative effect can be avoided by not using breakable side window as emergency exit (there are more technical solutions) or clean the window frame very carefully (it takes too much time) or cover the window frame by protective rag, see on Figure 1. (The problem is that generally the protective rag is not near at hand)

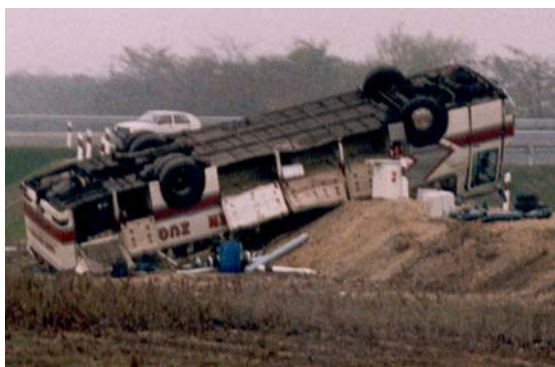
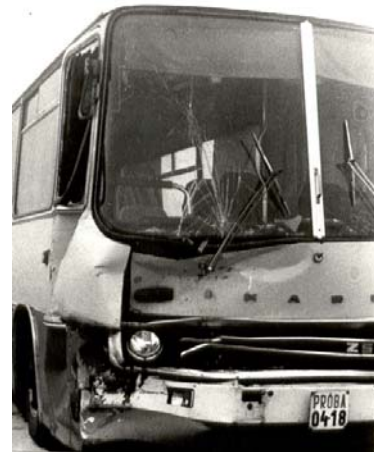
At the beginning it was not considered, but later it became evident that the EE-s can be used only if the bodywork of the bus – at least in the surroundings of the EE – is not strongly damaged. The large scale structural deformations generally prevent to access, to operate and use the EE. Figure 1. gives examples about the total collapse of the superstructure in rollover accidents. These pictures prove that in these cases it is meaningless to talk about EE-s. Figure 2. shows examples when only one, or just a few EE-s can not be used because of strong, local structural deformations.

**Figure 2. Local large-scale deformation of the bodywork**

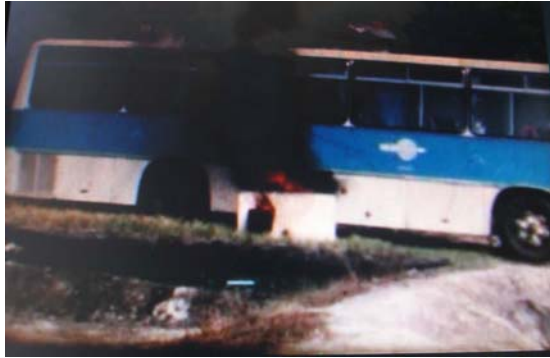
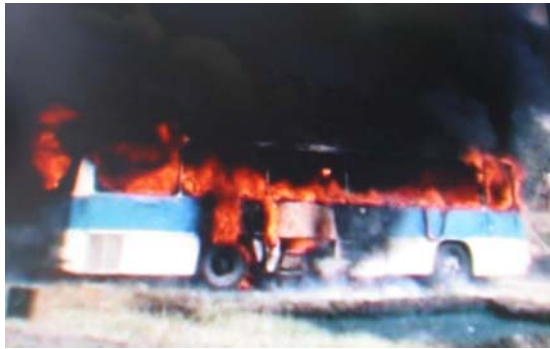
**Figure 3. Fire tests with complete bus type IK255**

Fire tests were carried out in Hungary with three complete buses (type IK 255 and IK 415) simulating five fire sources. Figure 3. shows one test when the whole fire propagation process was observed and studied with the measurement of temperature and some poisoning gas concentration increasing. [1] The source of fire was in the closed box of the heating device, under the floor. The measured values (CO, HCl, HCN gas concentrations; temperatures  $T_{far}$  far from the fire source and  $T_c$  close to that) are presented on Figure 4. Without detailed discussion of the test results it may be said that from the first possible observation of the fire, the available time for evacuation was in the range of 200-300 sec. The smoke density was not measured, but visually detected by filming it was developed very rapidly. The critical values of gas concentrations are marked by a horizontal line on the left side of the diagram. The life danger is mainly due to the gas and smoke concentration and less to the high temperature.

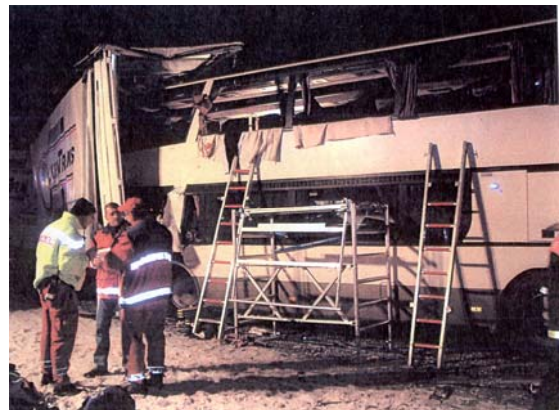
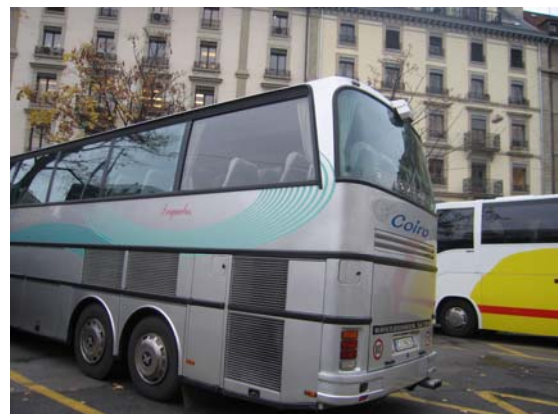
**Figure 5. Usability of side emergency window**

The assumption that the usability of a certain type of EE is the same in every bus categories is not true. Figure 5. shows the usability of the side emergency windows in case of double deck (DD) bus comparing the upper and lower level passenger

compartment (after a frontal collision) and also the situation on a high (but single) deck (HD) tourist coach. The side emergency window is a very useful exit in the case of the lower level of a DD bus or on low floor buses, but they cannot be used in the case of the upper level of a DD bus or on a HD coach.

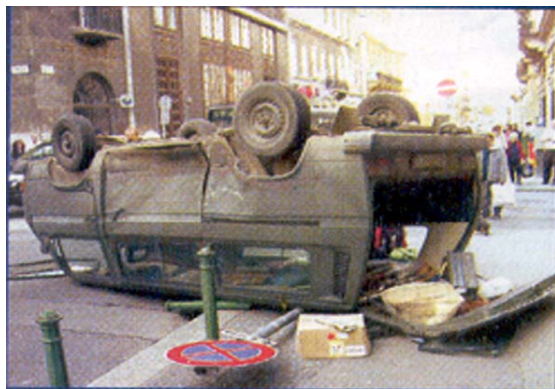
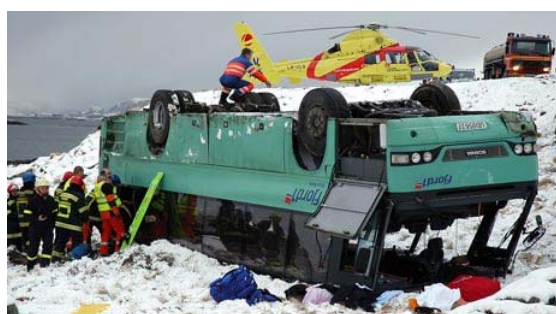
The assumption that the usability of a certain type of EE is the same in different accident situation is also not true. Figure 6. shows some examples. The escape hatches are absolutely not usable when the bus is laying on its roof. The side emergency windows are well usable (on both side) in this situation in large buses, but they are almost useless in small buses. For small buses the rear wall door is very useful in this case.

**Figure 6. Usability of escape hatches (?)**

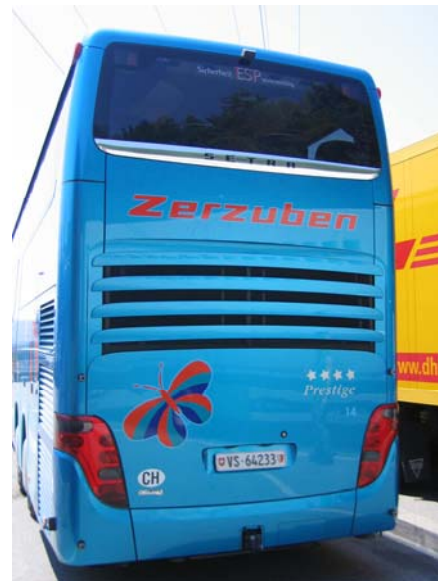
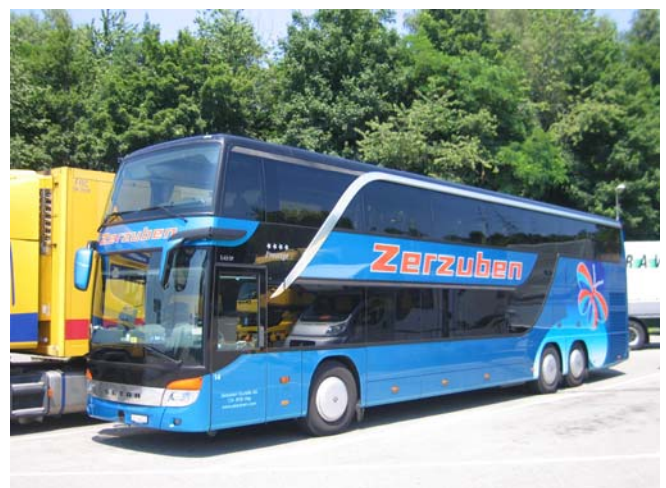
The assumption that all kind of EE-s have the same usability (they are equivalent and replaceable) is also not valid. Figure 7. gives a very clear argument considering and comparing all the possible (and required) EE-s on DD coaches, e.g. side windows, escape hatches, rear wall window, service door and the door of the driver compartment.

**Figure 7. Different emergency exits do not have the same usability**

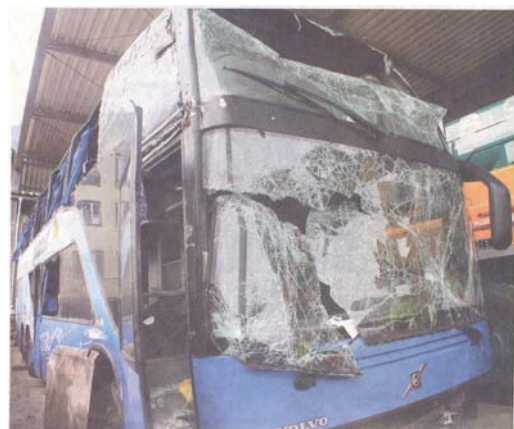
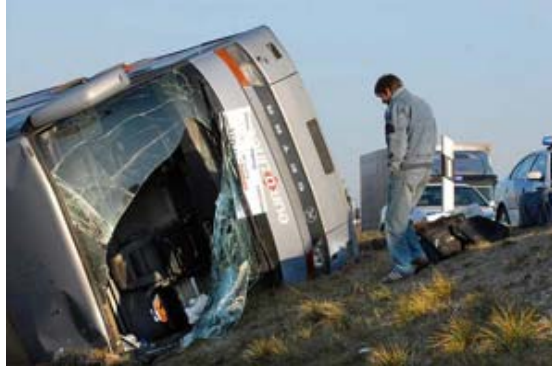
There is one important question to be raised. In the existing regulation the windscreen is not considered as possible EE. The reason of that is that the windcreens are made from laminated glass and therefore it is not breakable. But in the last few years a very effective new technology has been developed and already used by the firemen: to cut the laminated glass with a small (4 kg of mass) electric rescue saw. It could be placed in the driver's compartment. (similarly to the fire extinguisher) and if necessary, used by the driver. Figure 8. shows examples, when this device was used after an accident

by the fire brigade. It can be seen easily that the windscreen is one of the best, most usable EE in many accident situation, so in the future it should be considered.

**Figure 8. Using the windscreen as emergency exit by cutting it.**

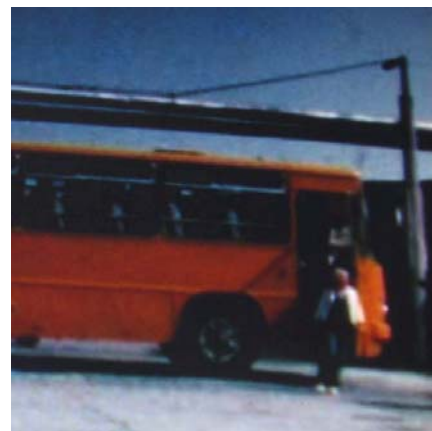
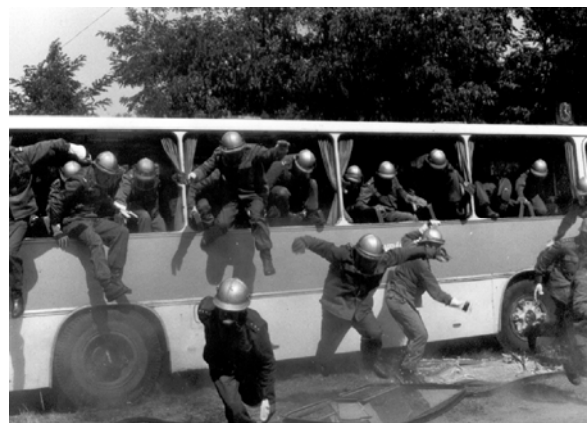
In this last case the firemen kicked out – in the same moment – all the side windows together with the rubber mounting on both sides of the bus and jumped out through the empty window frames, see Figure 13.

**Figure 13. Evacuation tests in Hungary: service door and side window**

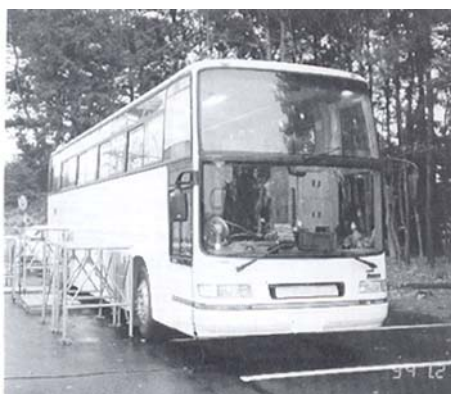
An interesting evacuation test series were carried out in Japan, JAMA [5]. They used a high deck coach and tested the use of service door, emergency door and emergency side window as EE. The passenger sample was built up from 6 schoolchildren (8-12 years) 12 adults (20-28 years) and 6 elderly people (66-73 years) Figure 14. shows the test bus and the three kinds of tests. The emergency window was not a breakable one, but sliding type. If the test passengers thought that it is dangerous to jump down to the ground either from the emergency door (floor height  $\approx$  1500 mm) or from the emergency window (wastrail height 2300 mm) they could use an outside podium (1500 mm high). They measured the evacuation time of every individual from starting the process (standing up from the seat) to the end (being outside, on the ground or on the podium). They repeated the test with every person three times. Some results:

**Figure 14. The coach used for evacuation tests in Japan**
